An assessment of gully erosion in Dutse Metropolis, Jigawa state Nigeria

Aminu Mansur. An assessment of gully erosion in Dutse Metropolis, Jigawa state Nigeria. *Discovery*, 2021, 57(302), 145-153

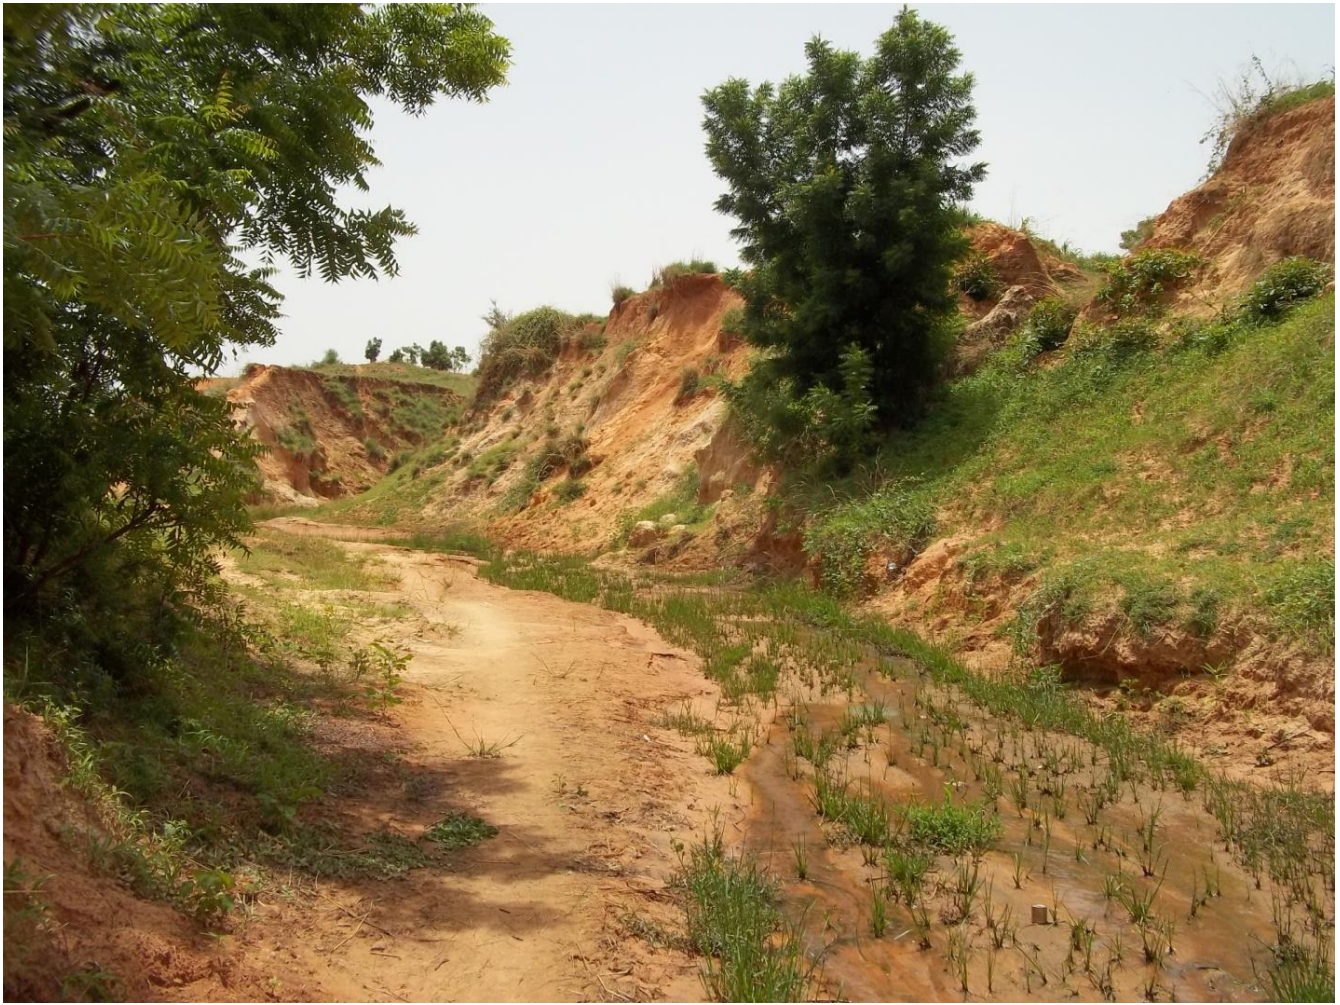
Figure 1 Gully showing massive washed out portion in Kargo

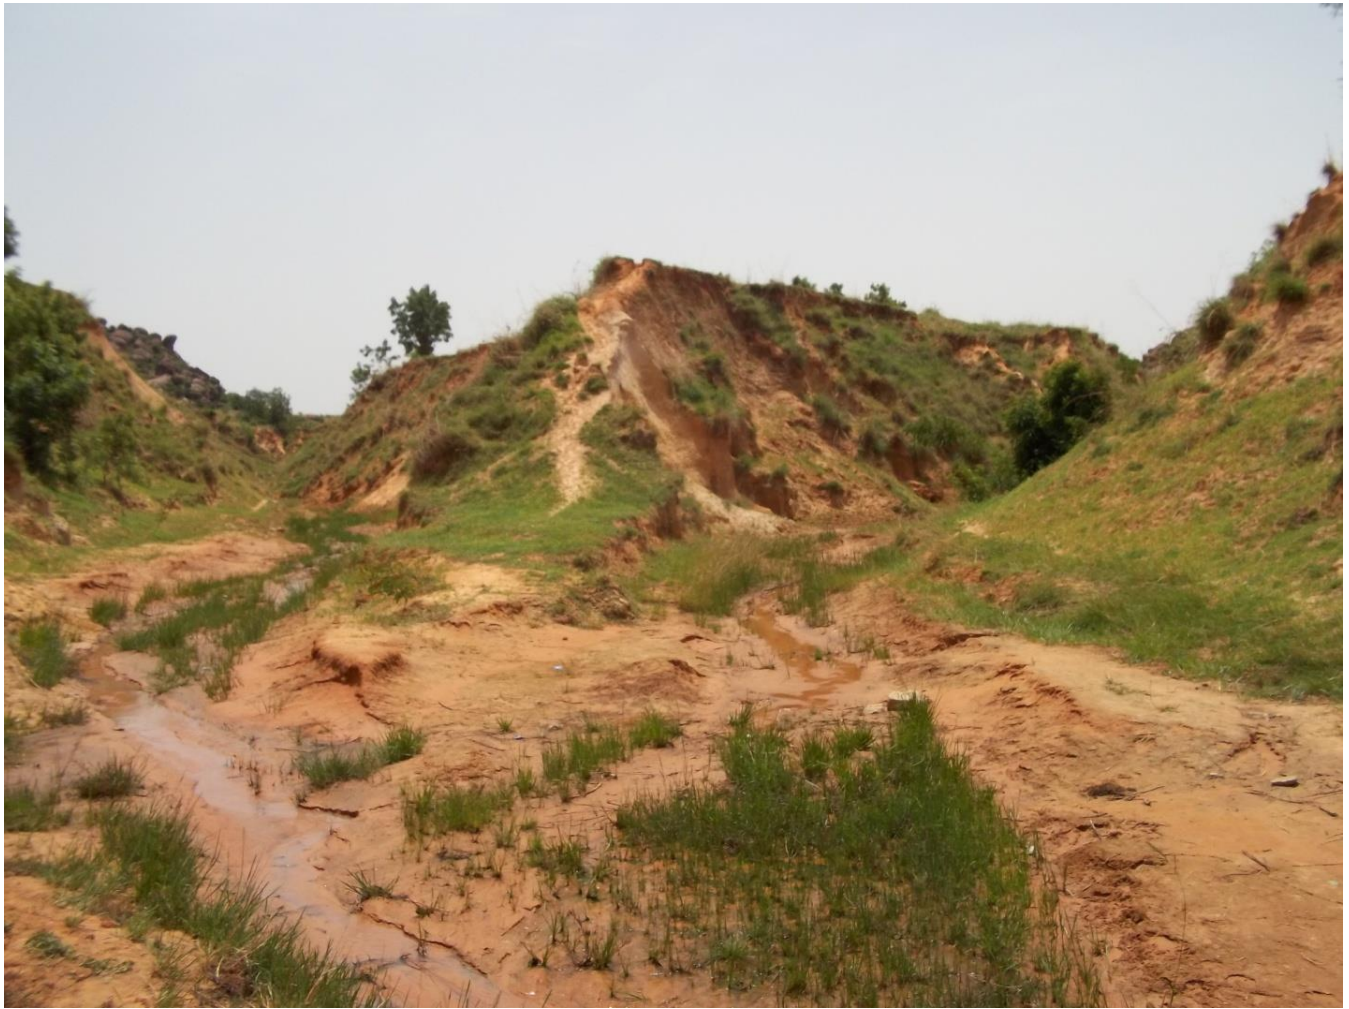
The commencement of the gully and enlargement in this area has its origin largely due to change in gradient in response to human induce vegetation change. The erosion of the embankment, the initiation and phenomenal advance of the gully was a product of a long period of evolution (figure 2). The gully is about 15.7m depth, 30.22m wide and 143.71m length, in the down slope of the gully laterite soil has been observed due to leaching resulting from heavy rainfall experienced over the years. Most of the nutrients are lost and therefore does not favor agricultural productivity.

Figure 2 Part of the gully embankment along Maranjuwa linking Yina to Janbo

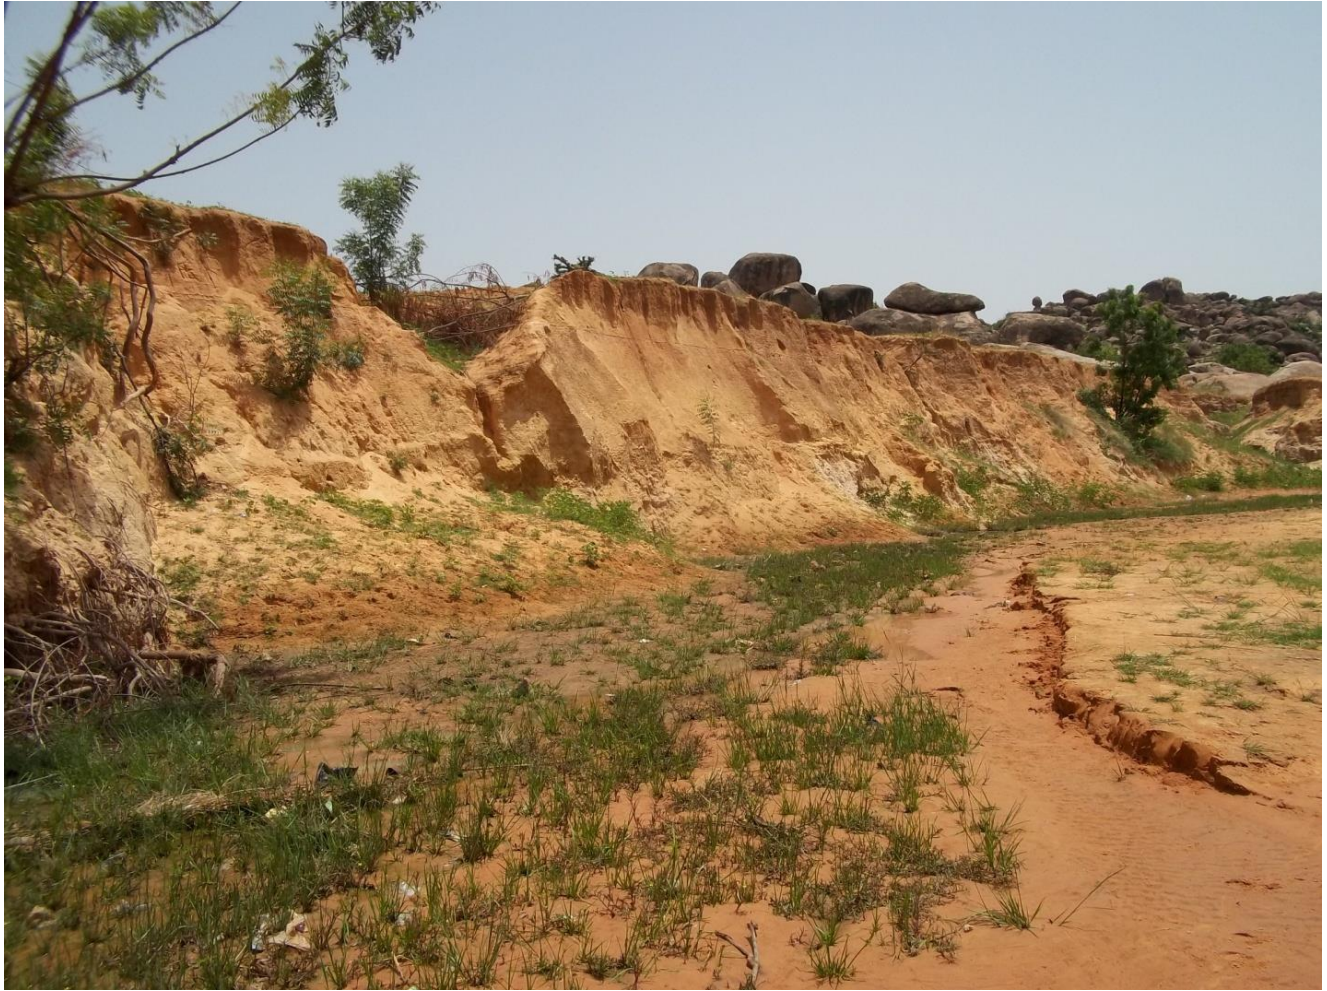
Figure 3 View of uprooted trees and slumping of gully wall in Kargo

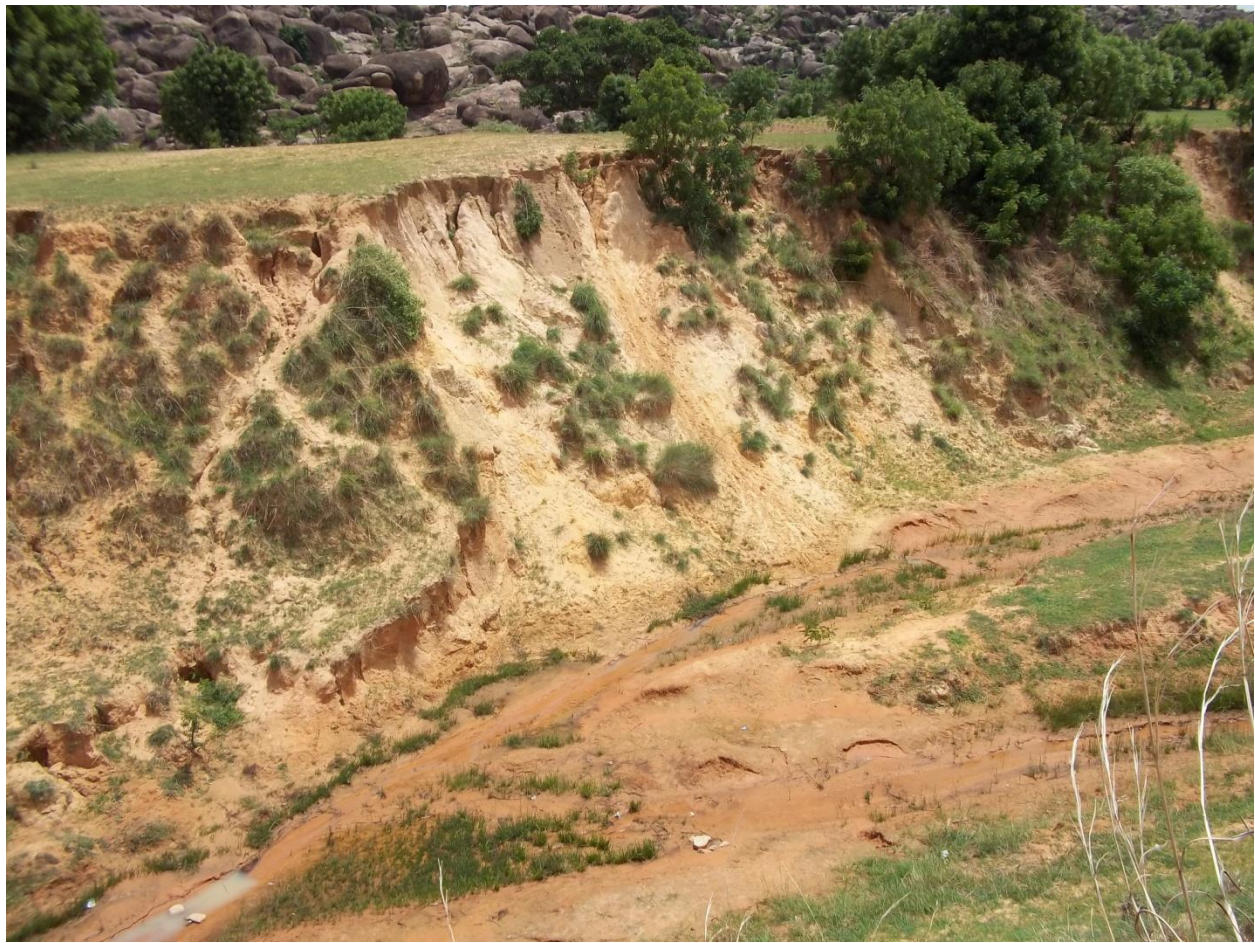
Heavy rainfall of approximately 65% normally around July-August alone with very high intensities, usually 70mmhr⁻¹; but as high as 90mm hr⁻¹ during rain storm triggered the formation and development of gully in this area (figure 4). Similarly, since the settlement is located on the hill top extensive flood used to occur at the down slope. Therefore, a lot of the rich top soil is lost to gully erosion, this consequently destroys farmlands, trees and crops these have serious effects on land development, e. g agriculture.

Figure 4 Falling and slumping of gully wall in Gandun fawa
